Geology and Hydrogeology of the Crosswicks Creek Tidal Wetlands

Field Trip

September 17 (Saturday). Leader: Pierre Lacombe, U.S. Geologic Survey.

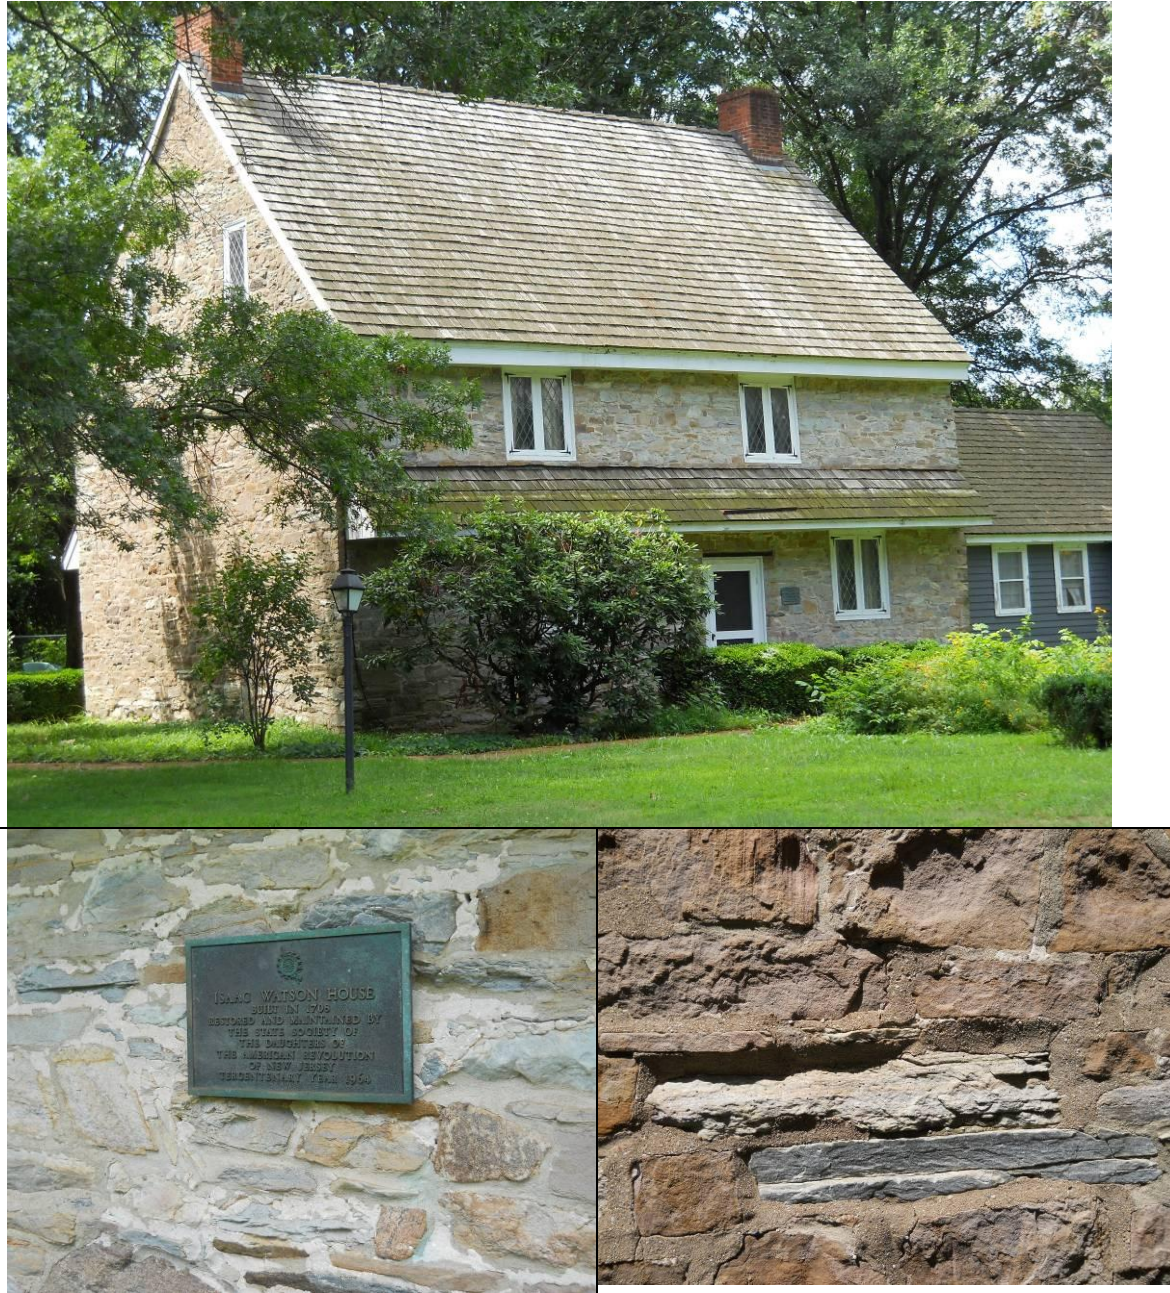
Figure 3. Photograph of the Isaac Watson House. House is constructed of metamorphic rocks of the Trenton Prong (north side) and Stockton sandstone of the Newark Basin (south side).

The basement metamorphic rocks do not outcrop within the marsh. They are at an altitude of -100 to -300 ft and have only been detected in wells in the marsh. The only places one can see the gneiss and schist in the marsh is as cobbles along the Delaware River shoreline; on the exterior walls of the Isaac Watson house (fig. 3), and in the walls of a private residence on Farnsworth Ave., Bordentown.

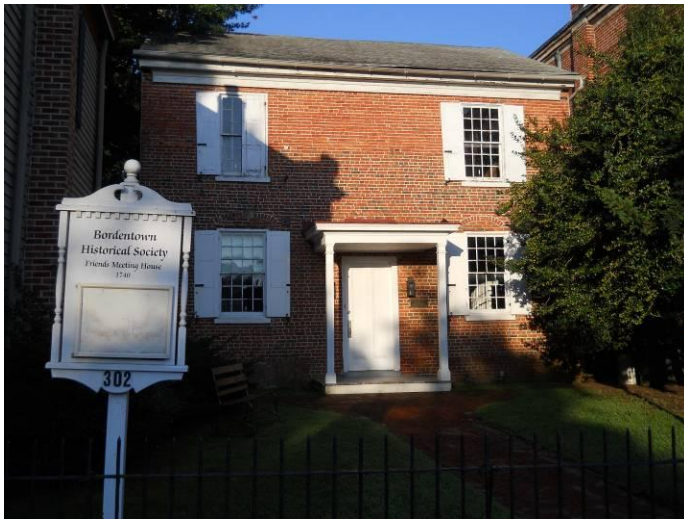
Figure 5. Quaker Meeting House Bordentown, bricks are likely from local Raritan clay/sand deposits

The red clays of the Potomac formations were locally mined for the pottery industry and brick industry. Many of the red bricks in the historical homes of Bordentown were mined from clay outcrops in the marsh area (fig 5 and 6A).

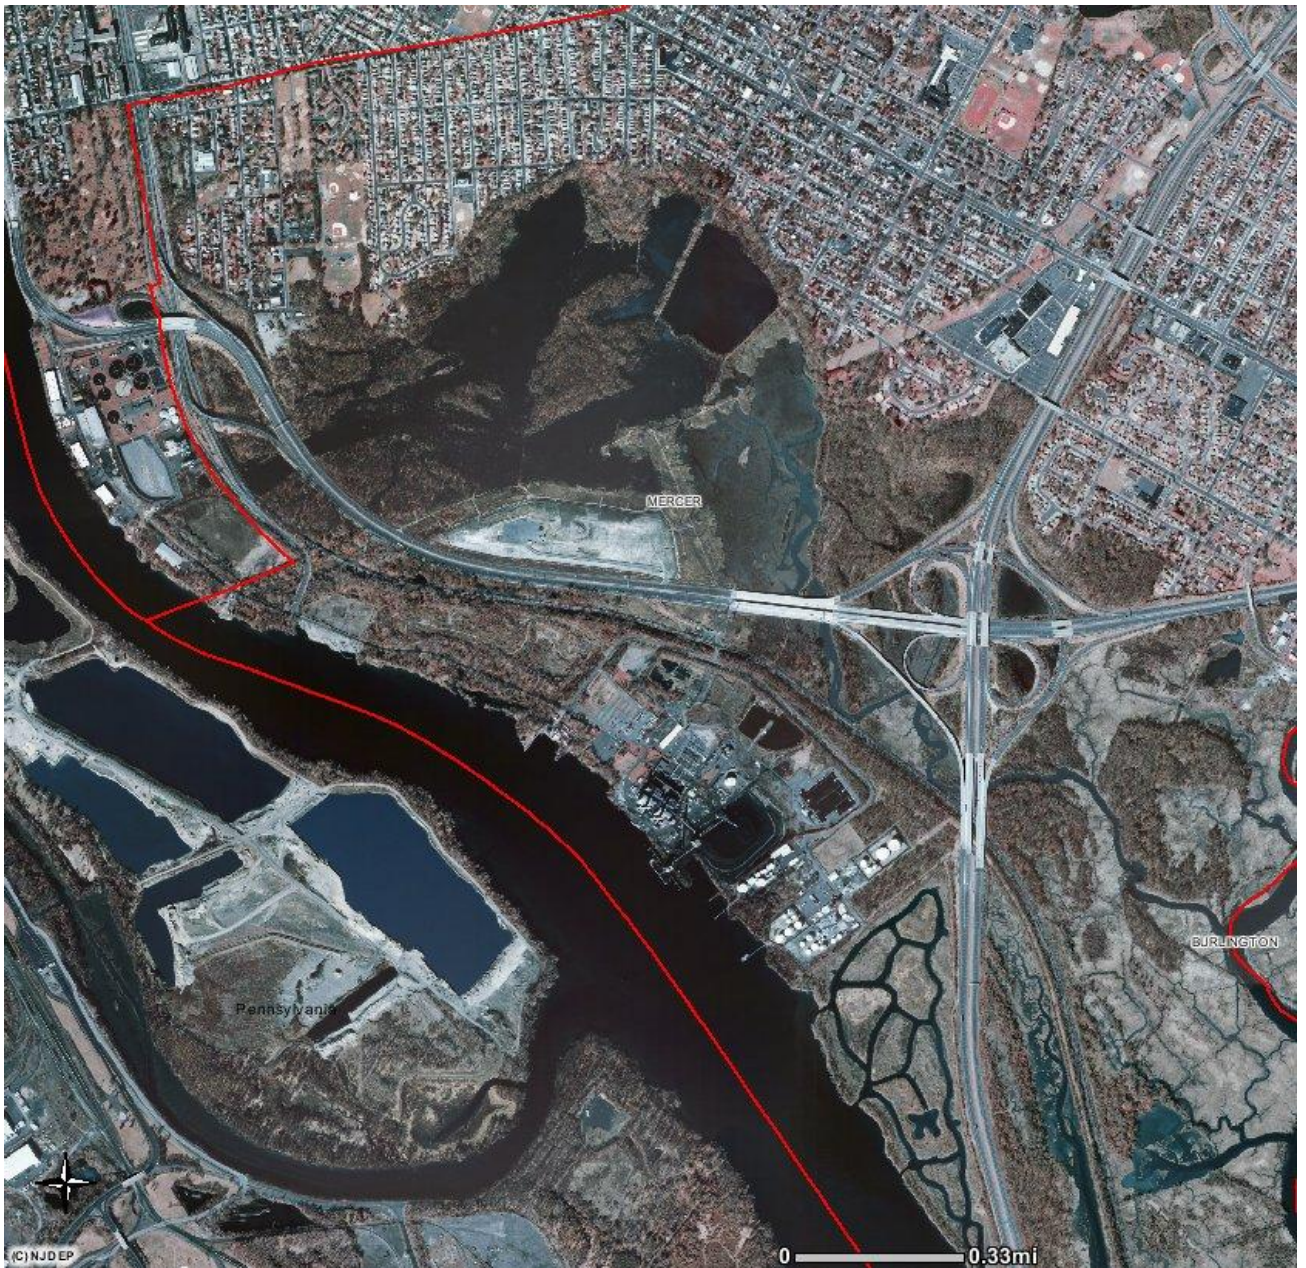
Figure 12. 2002-08 Air-photograph of northern Marsh showing (a) I-295, (b) I-129 (c) Duck Island electrical power plant, (d) Trenton landfill/dump, (e) Trenton sewage treatment plant, (f) Spring Lake, (g) artificial wetland (h) canal and light rail, (i) homes and residences south of Broadway and Laylor Streets.

Air photos of 1930 and 2010 show changes in land use of the marsh

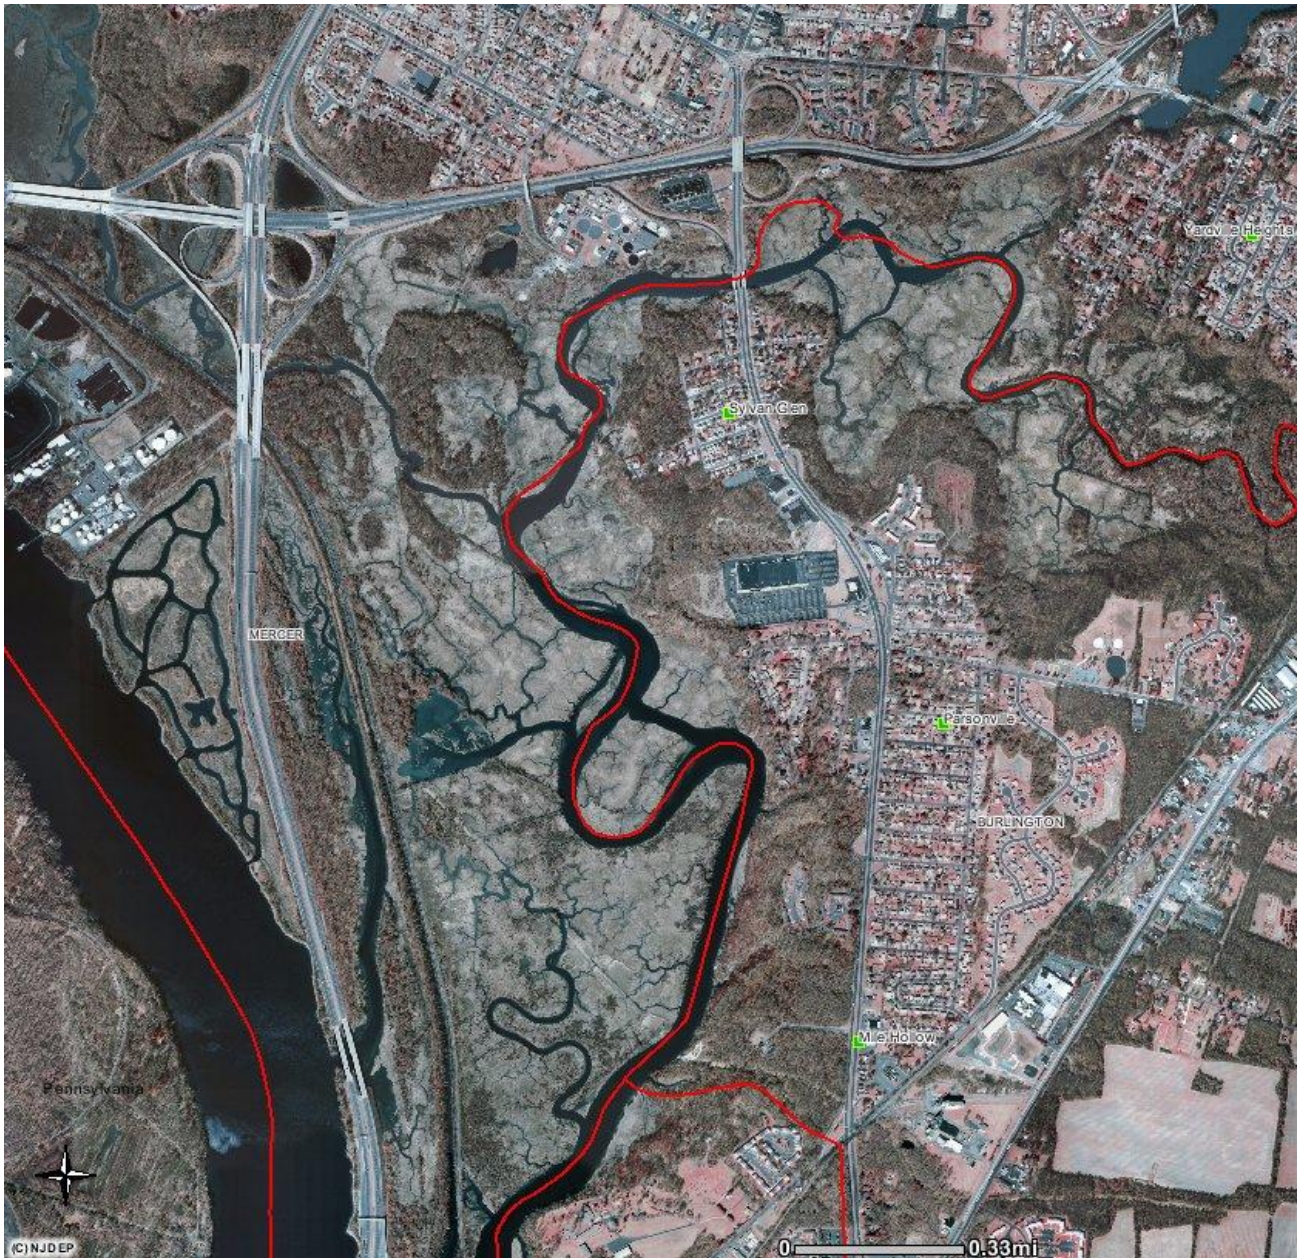
Figure 14. 2002-08 Air-photograph of southern Marsh showing (a) I-295, (b) I-129 (c) Duck Island electrical power plant, (d) Hamilton sewage treatment plant, (e) artificial wetland, (f) canal and light rail, (g) residences and businesses along Route 206
